Manhole Inspection Summary

Manhole # S19KK_018MH

Insp Date: **6/6/07 8:45 AM**

Location Address: **1909 WALBROOK AVE**

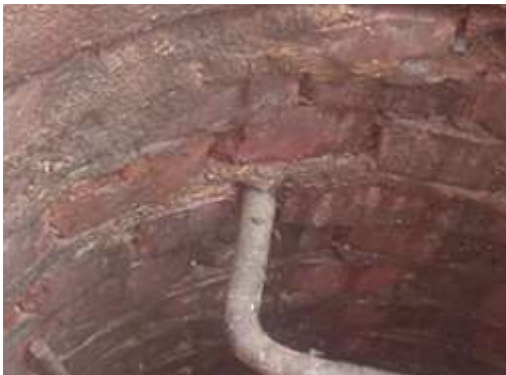
Defect 2

DETERIORATION OF CORBEL

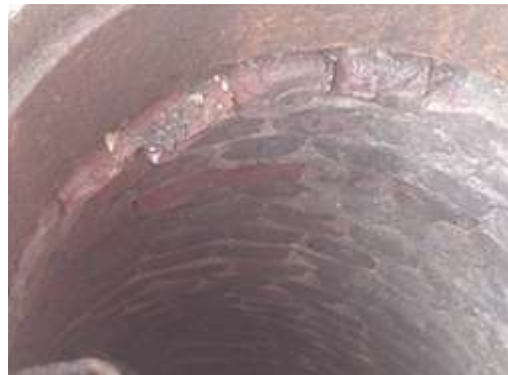
Defect 1

Condition: ☐ Sound ☐ Cracked ☐ Root Intrusion ☒ **Loose Brick** ☐ Deteriorated

LOOSE CORBEL BRICKS

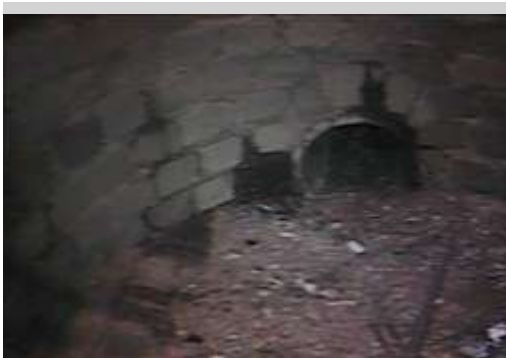
Defect 3

Infiltration: ☐ None ☐ Joint ☐ Cracks ☐ Mortar ☐ Roots ☒ **Wall**

BARREL INFILTRATION

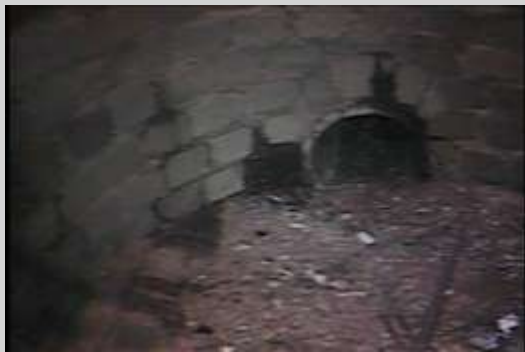
12 O'Clock Outflow

LOOKS LIKE WALL IS LEAKING ABOVE
PIPE
